NUCLEAR SAFETY, SECURITY AND SAFEGUARDS IN UKRAINE

2nd Summary Report by the Director General

28 April – 5 September 2022

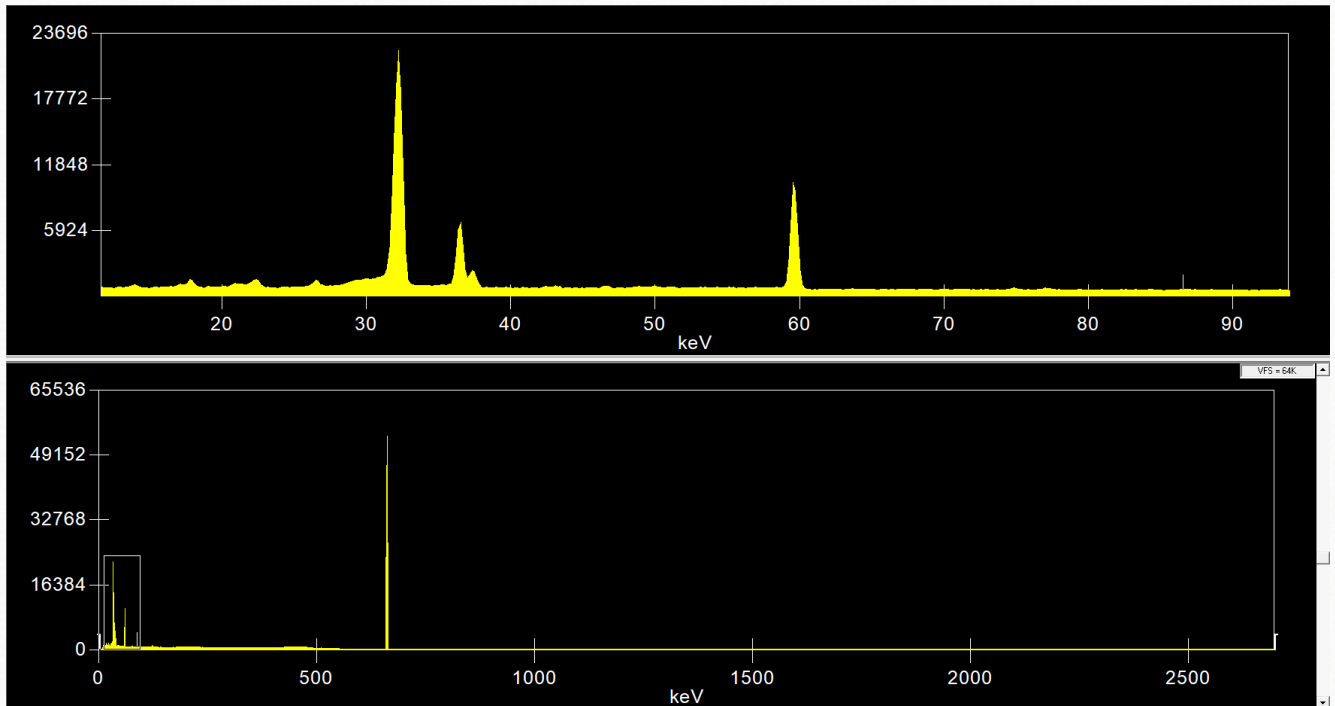
Figure 1. Gamma-spectrum of one soil sample showing the americium-241 gamma peak at 59.5 keV, and caesium-137 X-rays in the 30 keV region.

The results ranged from 0.2 $\mu\text{Sv/h}$ to 0.75 $\mu\text{Sv/h}$, which is 3–5 times above the dose rate on the nearby road. Environmental samples taken during the mission were analysed at the IAEA laboratories in Seibersdorf.
