NUCLEAR SAFETY, SECURITY AND SAFEGUARDS IN UKRAINE

2nd Summary Report by the Director General

28 April – 5 September 2022

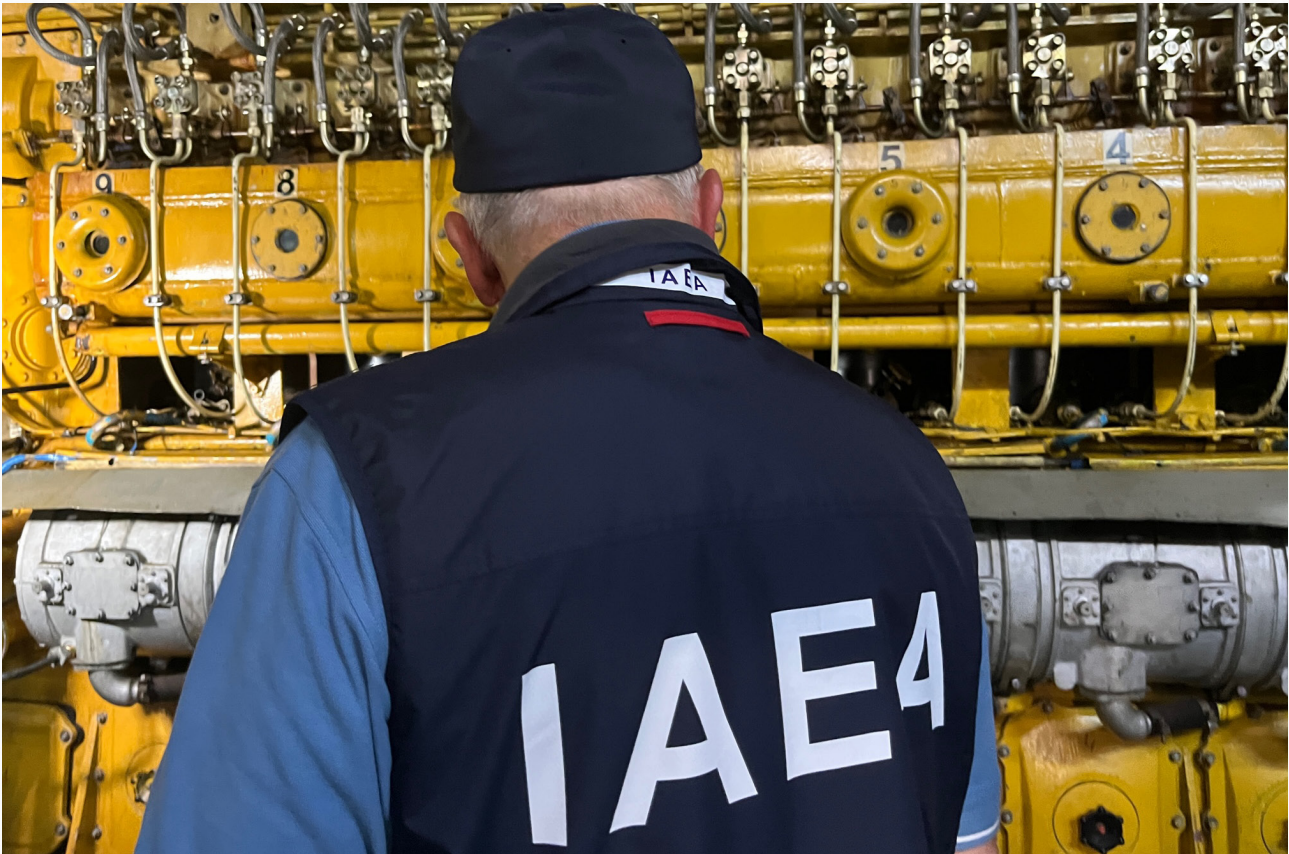
59. The Ukrainian plant staff and managers reported to the team that 17 EDGs (including two common EDGs for the site) for Units 1 to 5 had started as per design and that Unit 6 had entered into islanding operation mode and supplied its own power supply when the plant had lost all four external power supply lines on 25 August before the 750 kV/330 kV power line to the thermal power plant had been restored. All six units have the capacity to enter into islanding operation mode and to supply power to other units on site with 3–4 hours needed to complete the connection process.

60. It was also confirmed to the team that normally each EDG had a fuel inventory to sustain its operation for ten days, and that there were 2250 tonnes of diesel fuel available for the whole site. The plant had a contract with fuel suppliers; however, the delivery of the fuel to the ZNPP site had been complicated by the current situation, and discussions were in progress to enable fuel to be delivered to the site.

IAEA experts visiting the emergency diesel generator room of Unit 5 at the ZNPP. (Photo: IAEA)

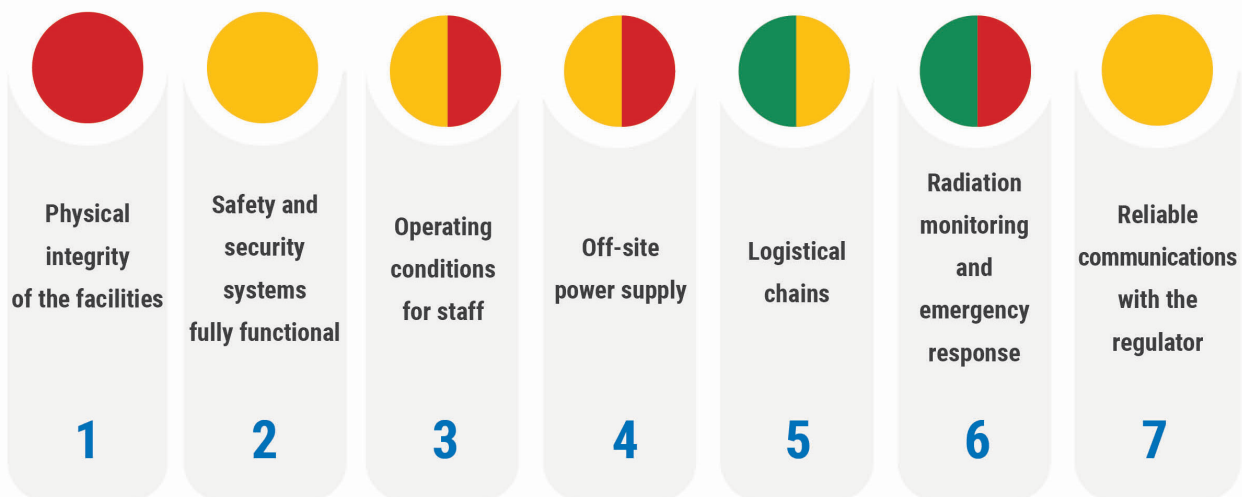
Infographic on the main findings from the ISAMZ regarding the Seven Pillars, presented at the press conference on 2 September. The infographic depicts: (1) damage observed at the site, (2) operability of safety and security systems, (3) challenging conditions for operating staff, (4) damage to off-site power supplies, (5) impact of broken supply chains, (6) operability of routine radiation monitoring and emergency arrangements on the site, and (7) challenges in maintaining routine regulatory oversight of the ZNPP and routine communications with the SNRIU.
